SEBAGO LAKE

SUBWATERSHED ASSESSMENT AND PRIORITIZATION

September 2015

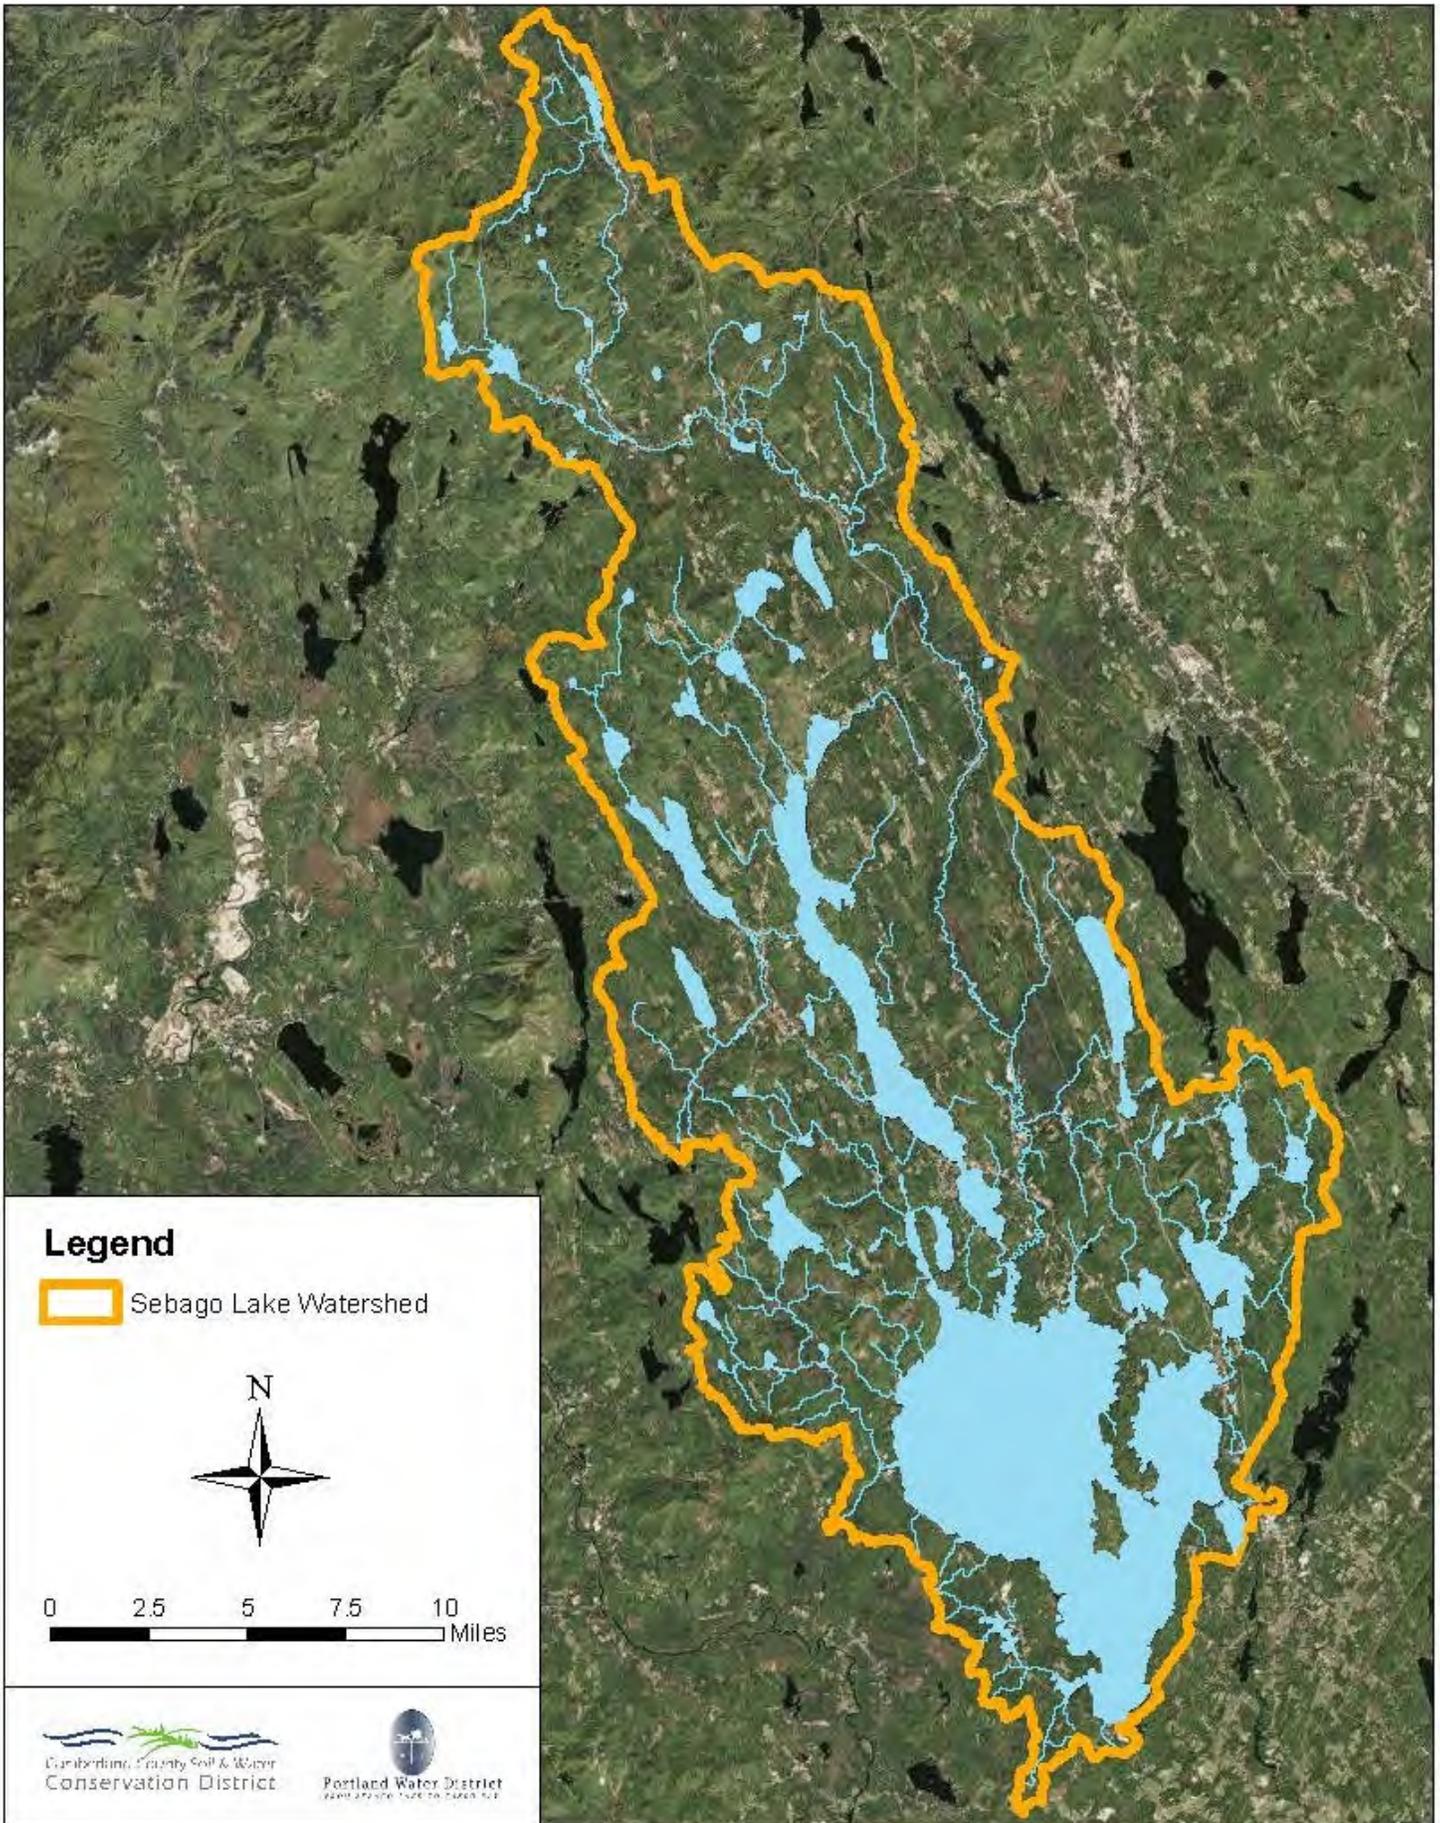
Figure 1. Greater Sebago Lake watershed.

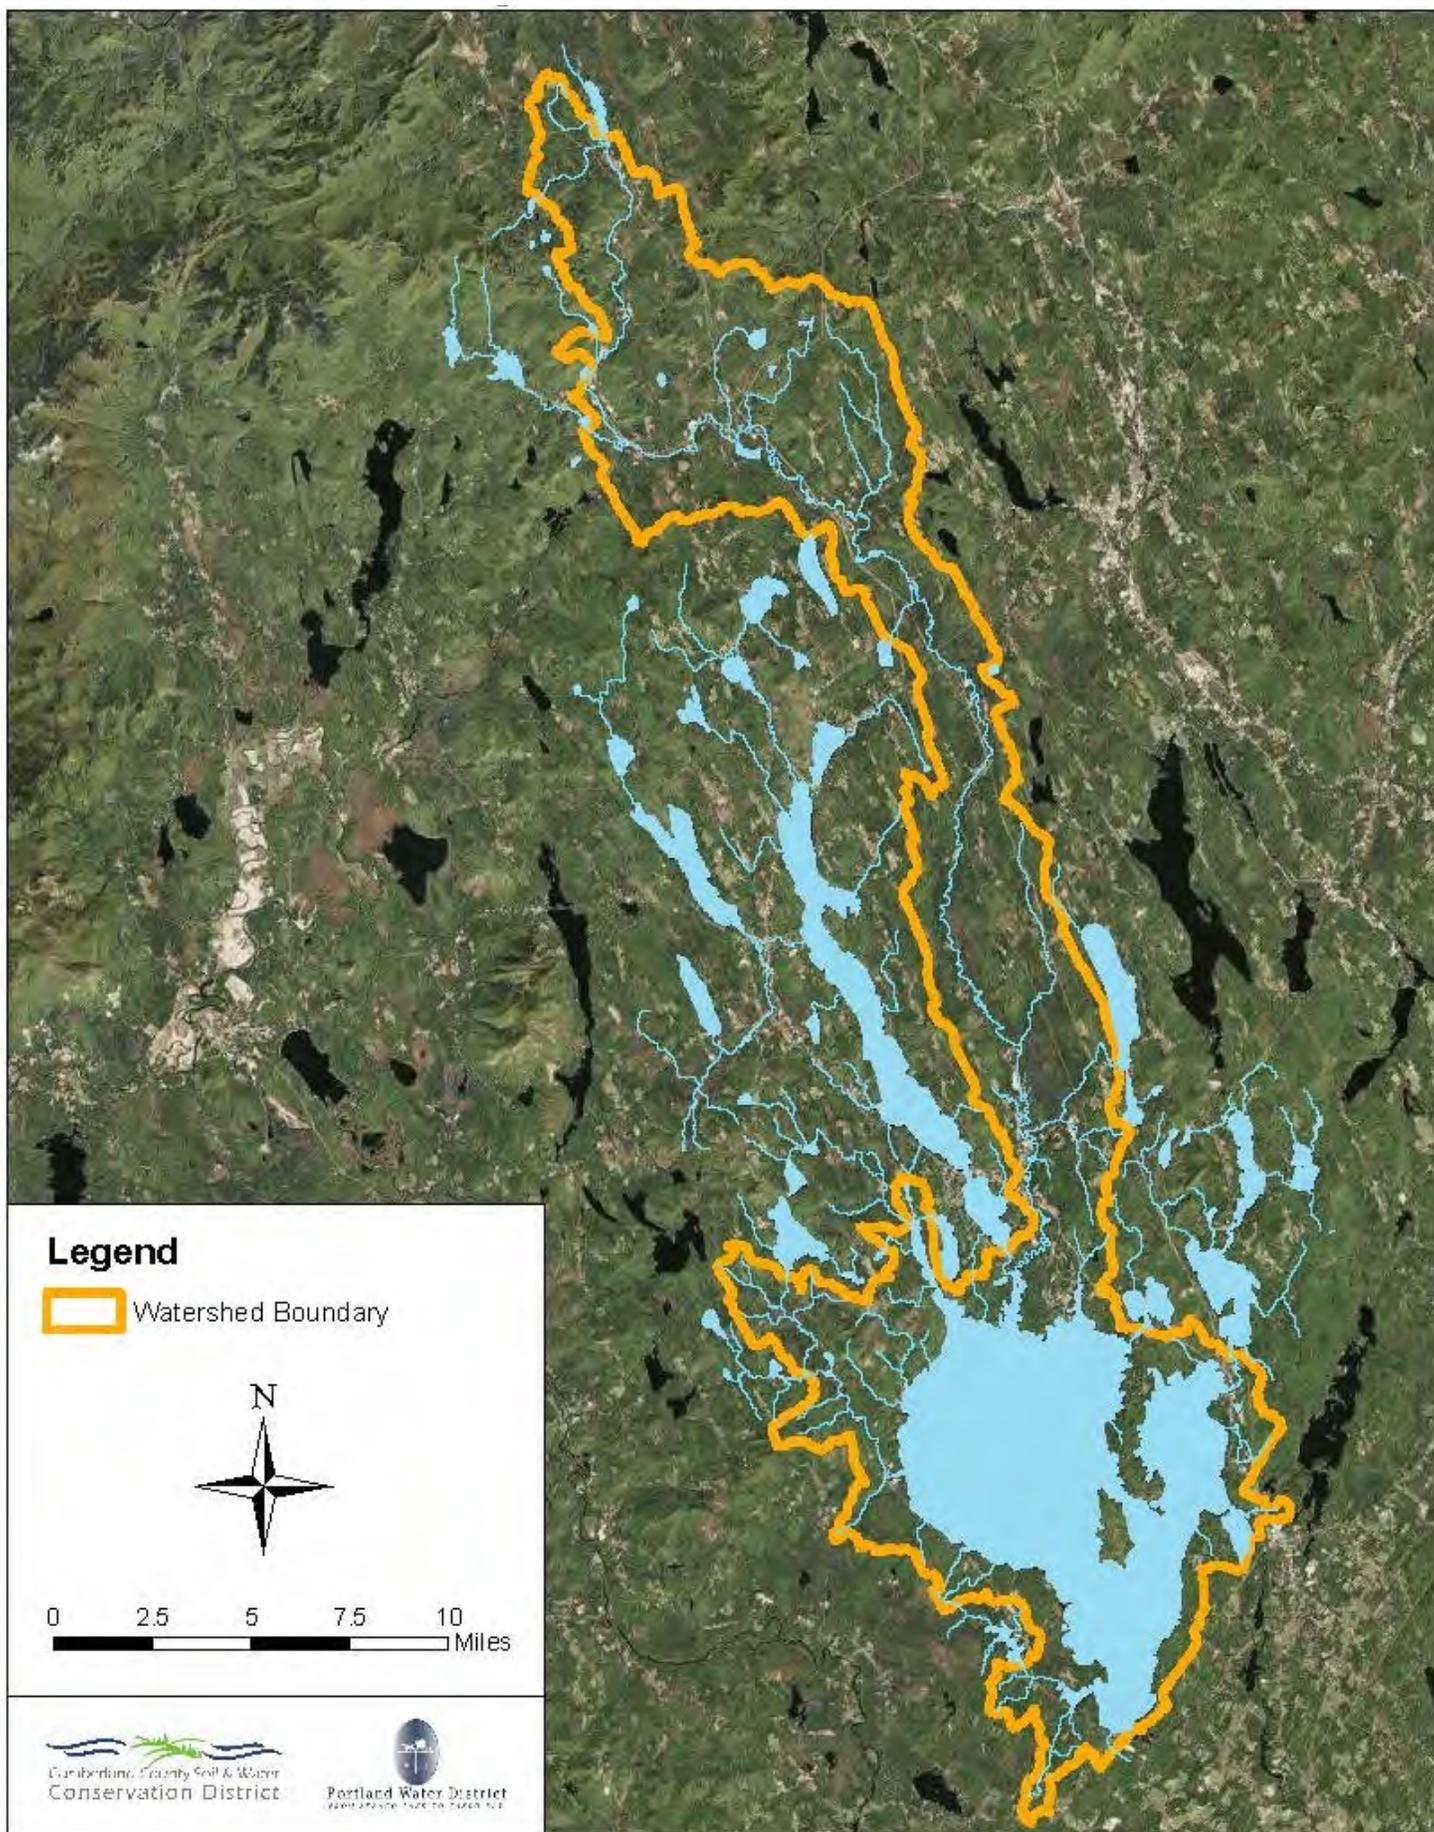
Figure 2. Sebago Lake direct watershed.

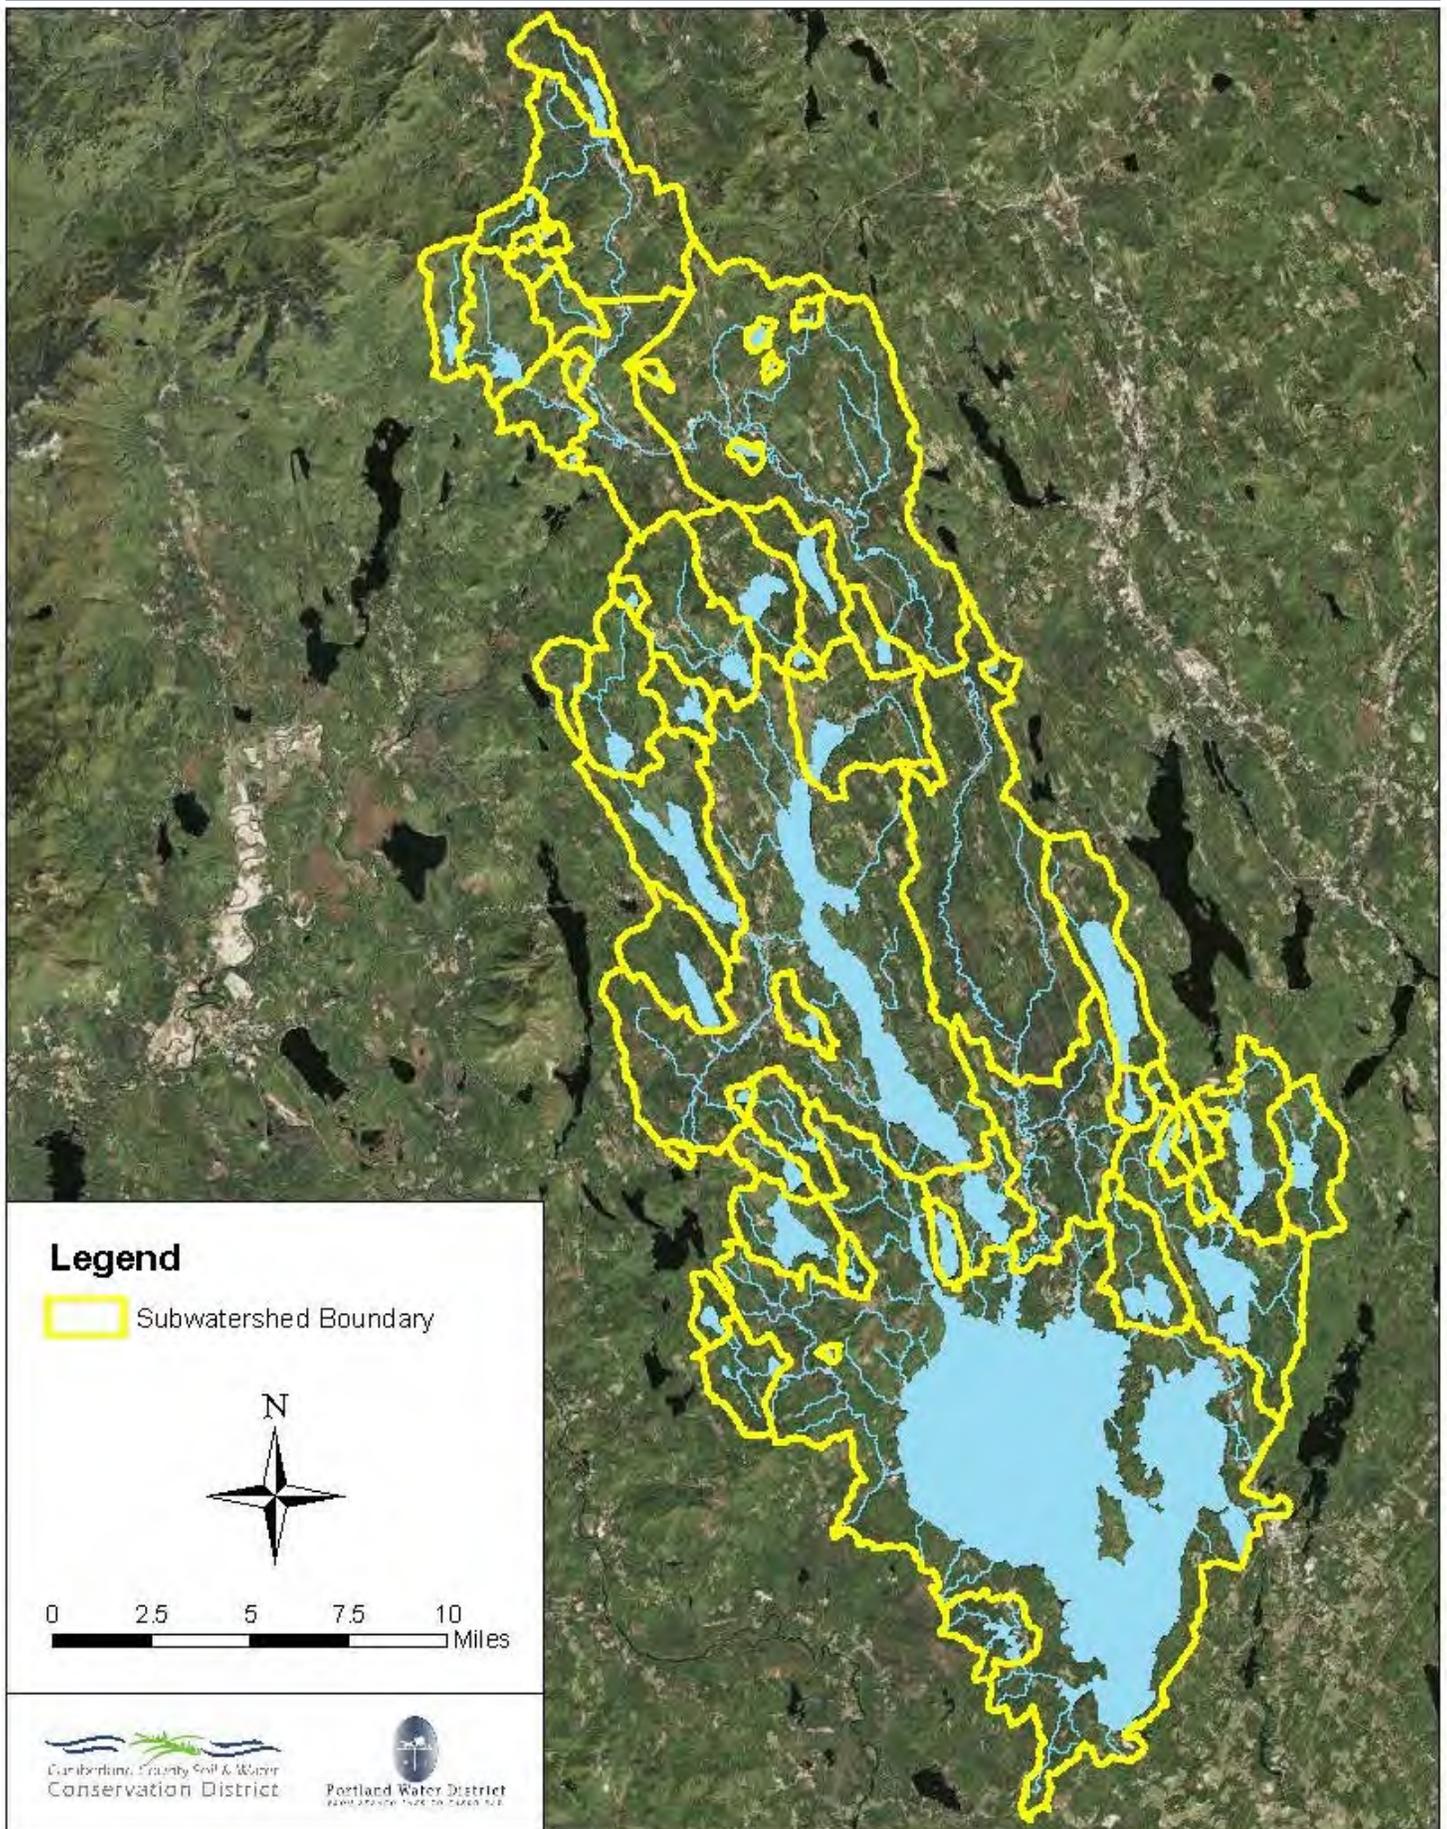
Figure 5. Sebago Lake subwatersheds for the water quality index.

The WQI for each subwatershed synthesized between 10 and 40 years of data from each of these four categories to prioritize each subwatershed for investments in NPS and other water quality improvement projects. Detailed methodology for each WQI parameter is provided in **Section V**.

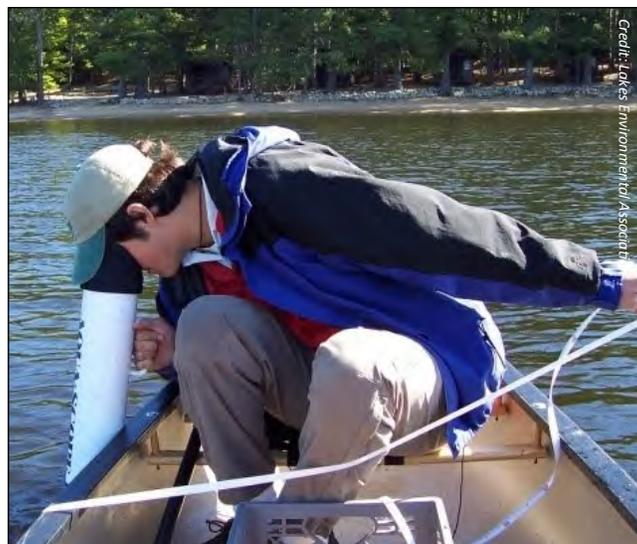
Lake transparency is measured using a Secchi disk.

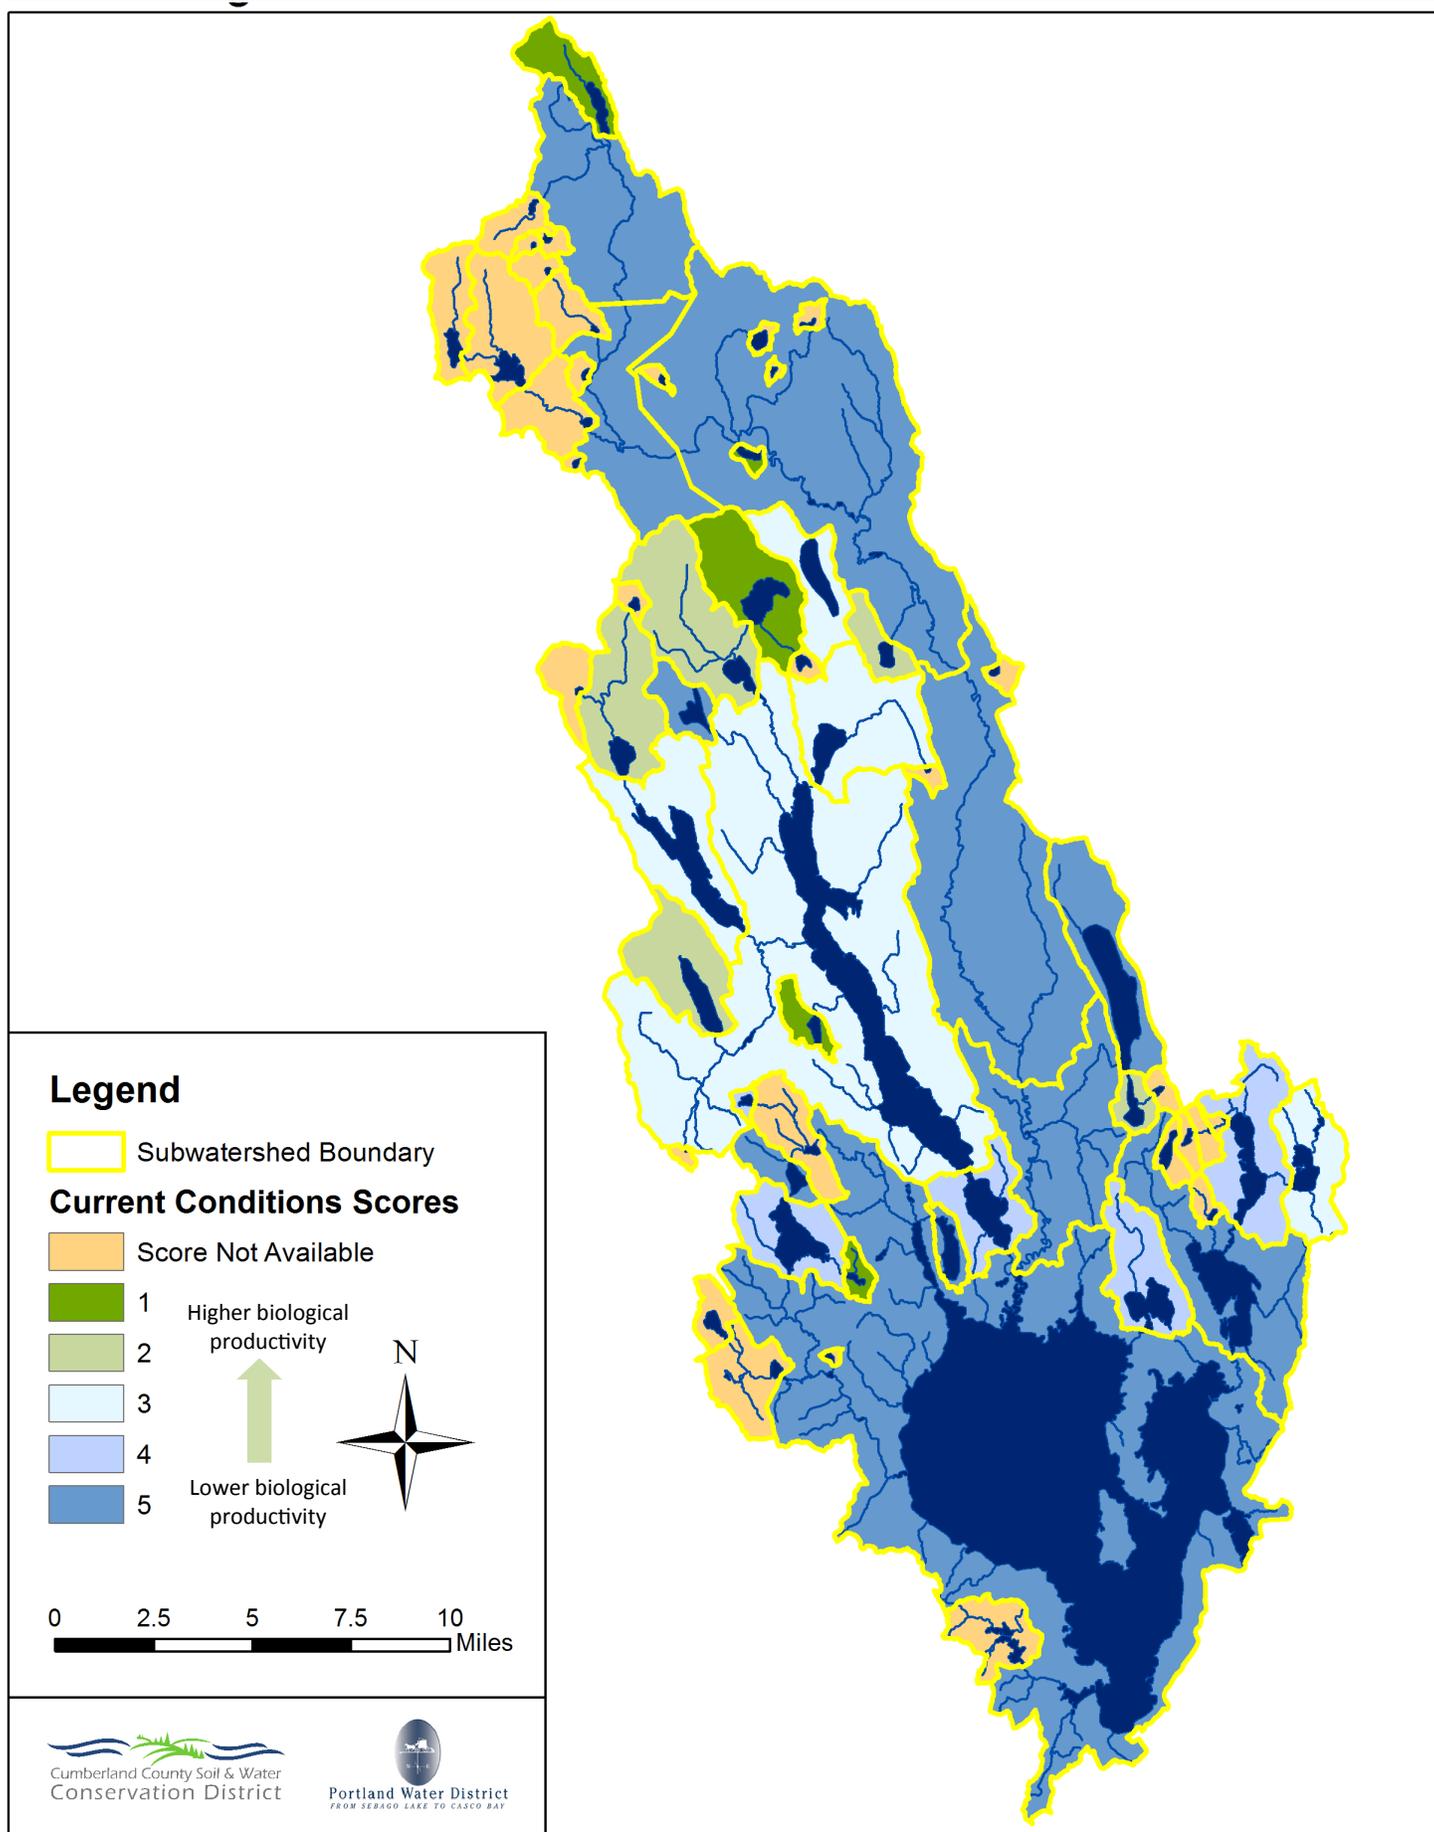
Figure 6: Sebago Lake subwatershed current conditions scores

It was important to the current study that lakes in the Sebago Lake Watershed be compared to each other, rather than to the TSI values of lakes across the state of Maine (**Table 7**). To achieve this, quintiles of TSI values for the subwatersheds were calculated. This allowed the formation of five condition classes based on the ranges of TSI observed. The current condition ranking criteria are provided in **Table 8**. Current condition scoring of each subwatershed is shown in **Figure 6**.

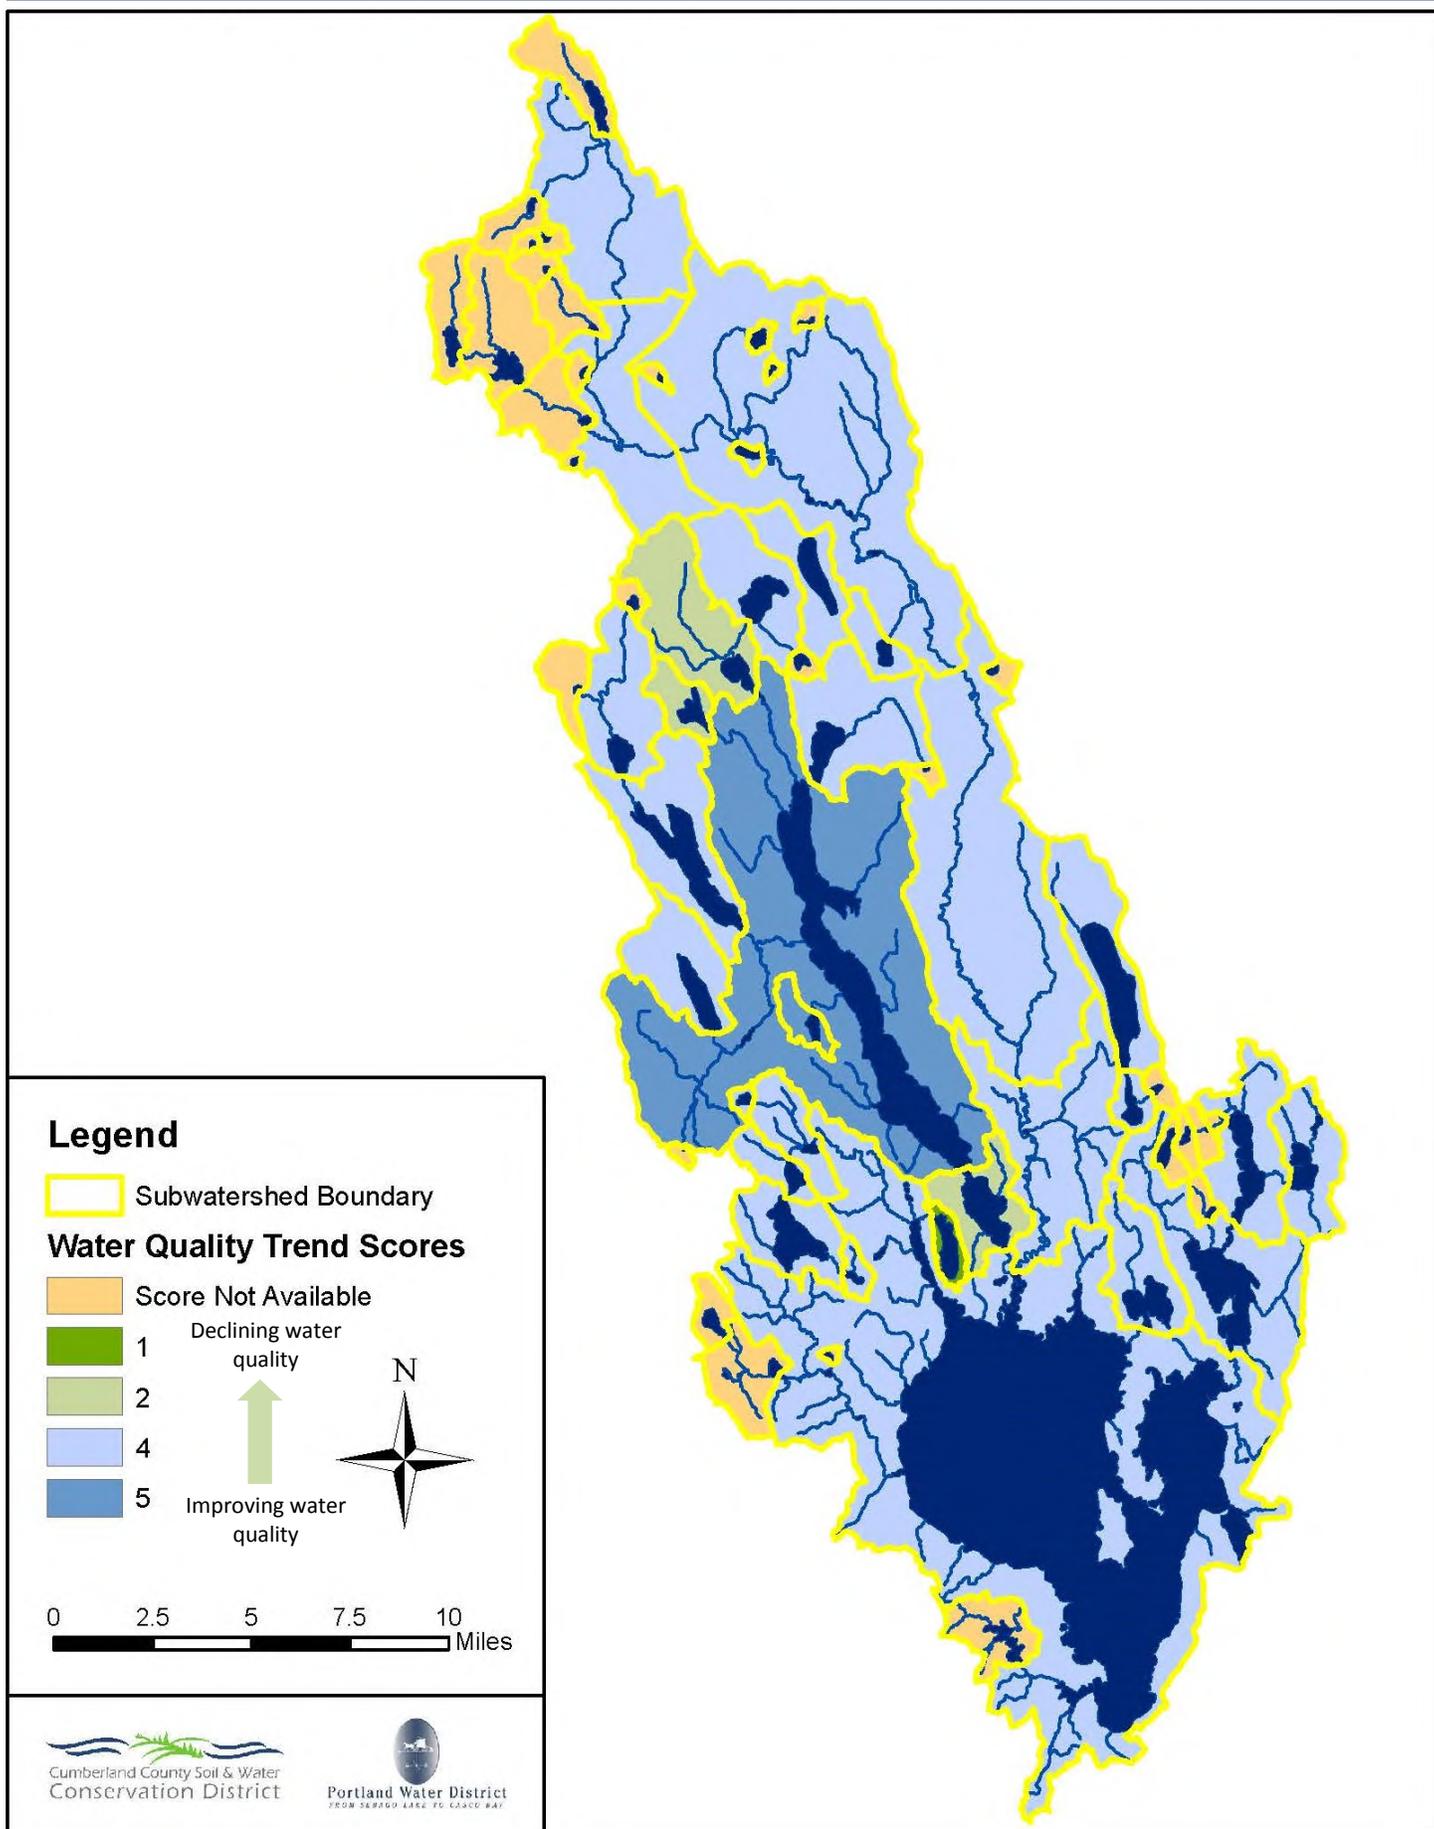
Figure 7: Sebago Lake subwatershed water quality trend scores.

Significant Mann-Kendall results with a positive Tau value indicate increasing chlorophyll-*a* concentration over the years, and therefore a worsening water quality trend. Alternatively, significant results with a negative Tau value indicate decreasing chlorophyll-*a* concentration over the years, and therefore an improving water quality trend. Secchi transparency decreases with increasing trophic state; therefore lakes with Secchi transparency data only (i.e., inadequate chlorophyll-*a* data for statistical analysis) show the inverse of the chlorophyll-*a* statistical criteria. The criteria for these overall scores are presented in **Table 10**. Water quality trend scores for each subwatershed are shown in **Table 11** and **Figure 7**.

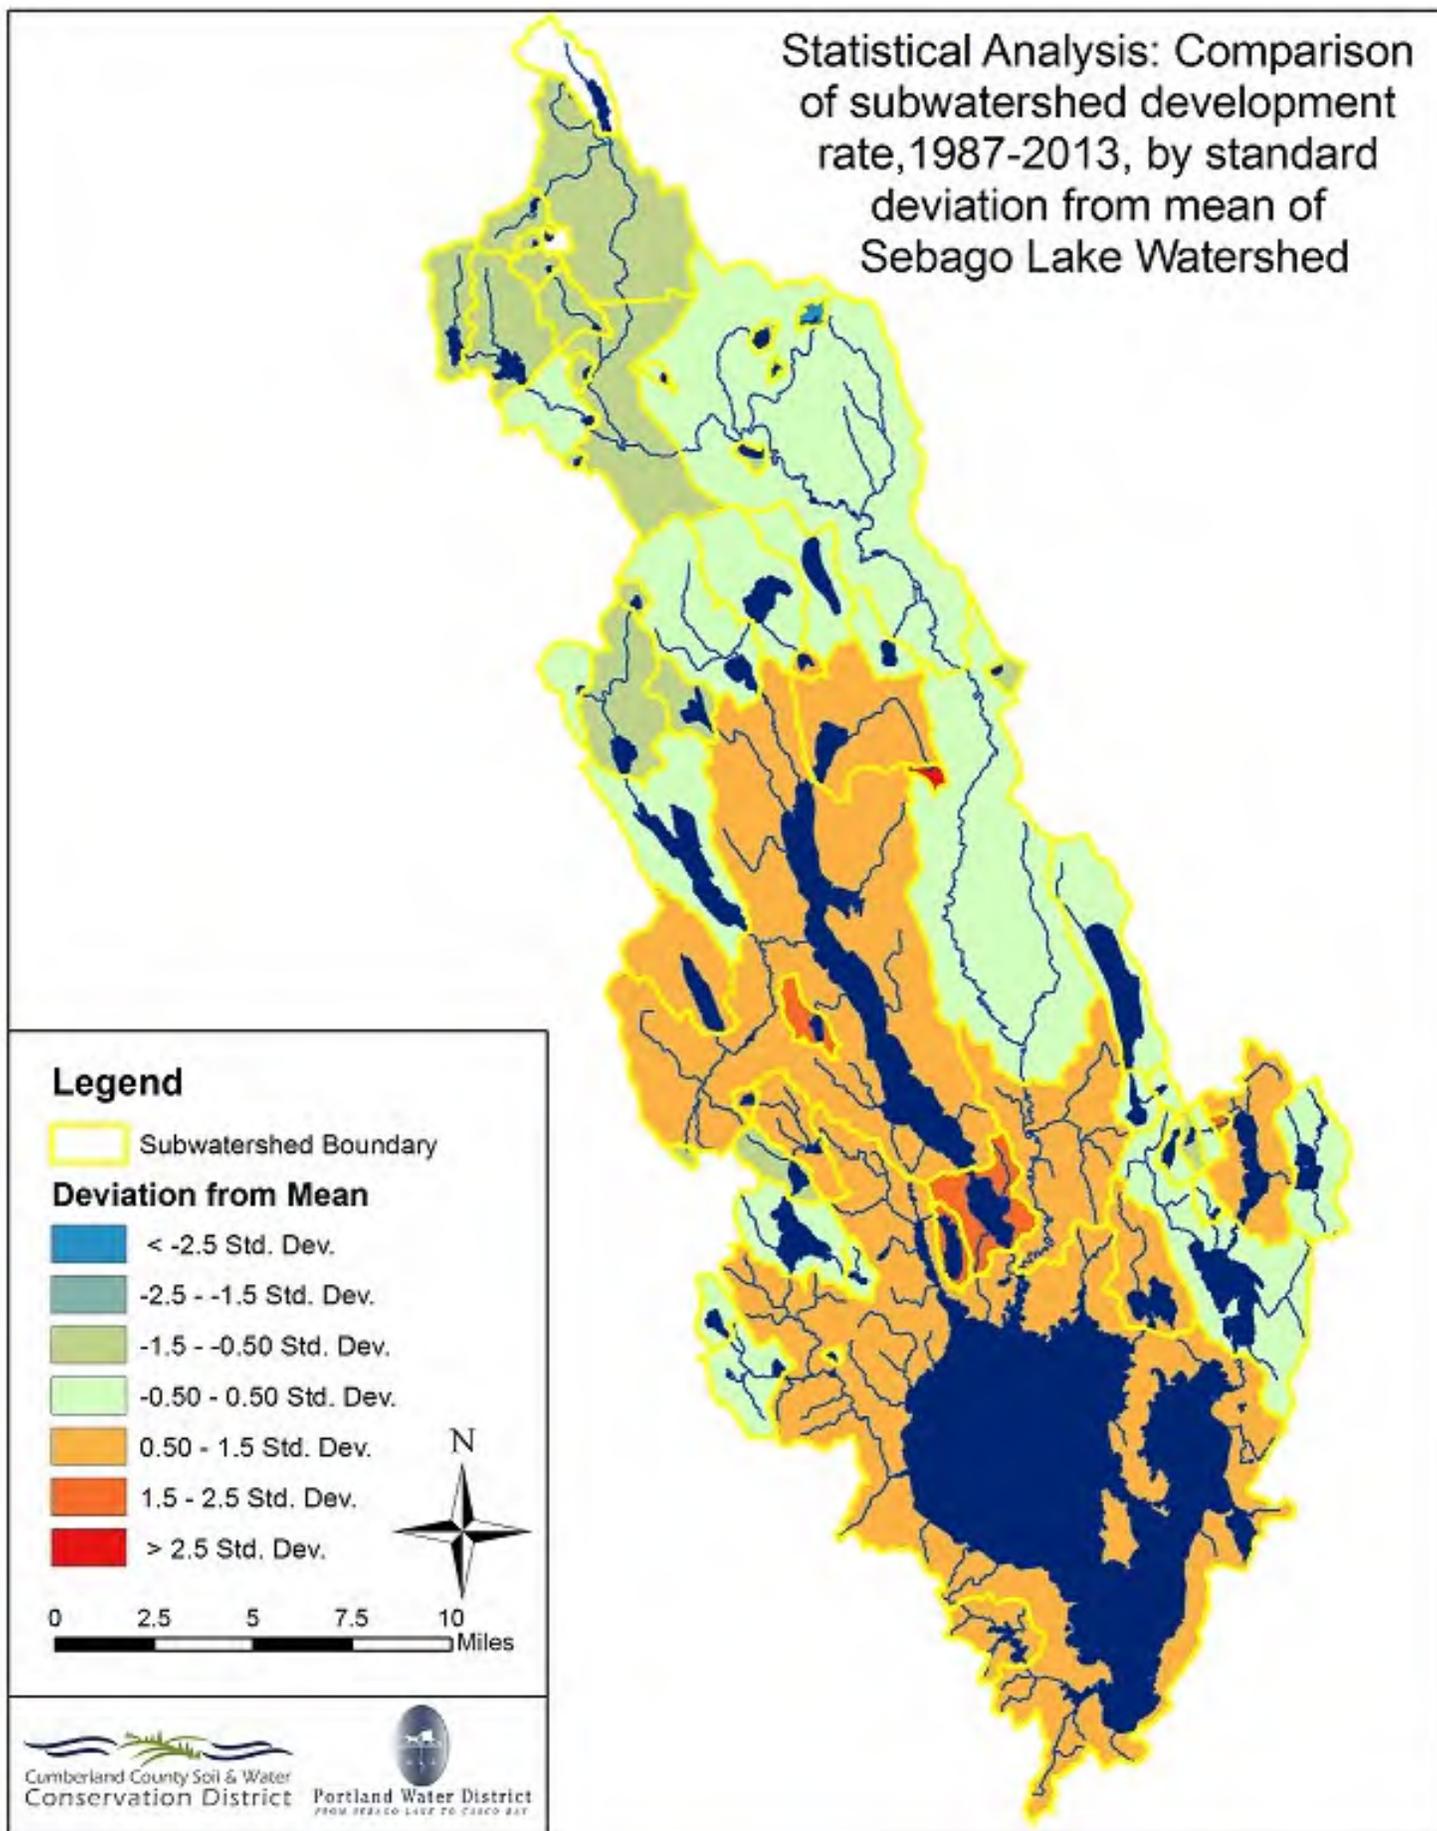
Figure 8. Comparison of individual subwatershed growth to greater watershed's growth median.

Statistical Analysis: Comparison of subwatershed development rate, 1987-2013, by standard deviation from mean of Sebago Lake Watershed

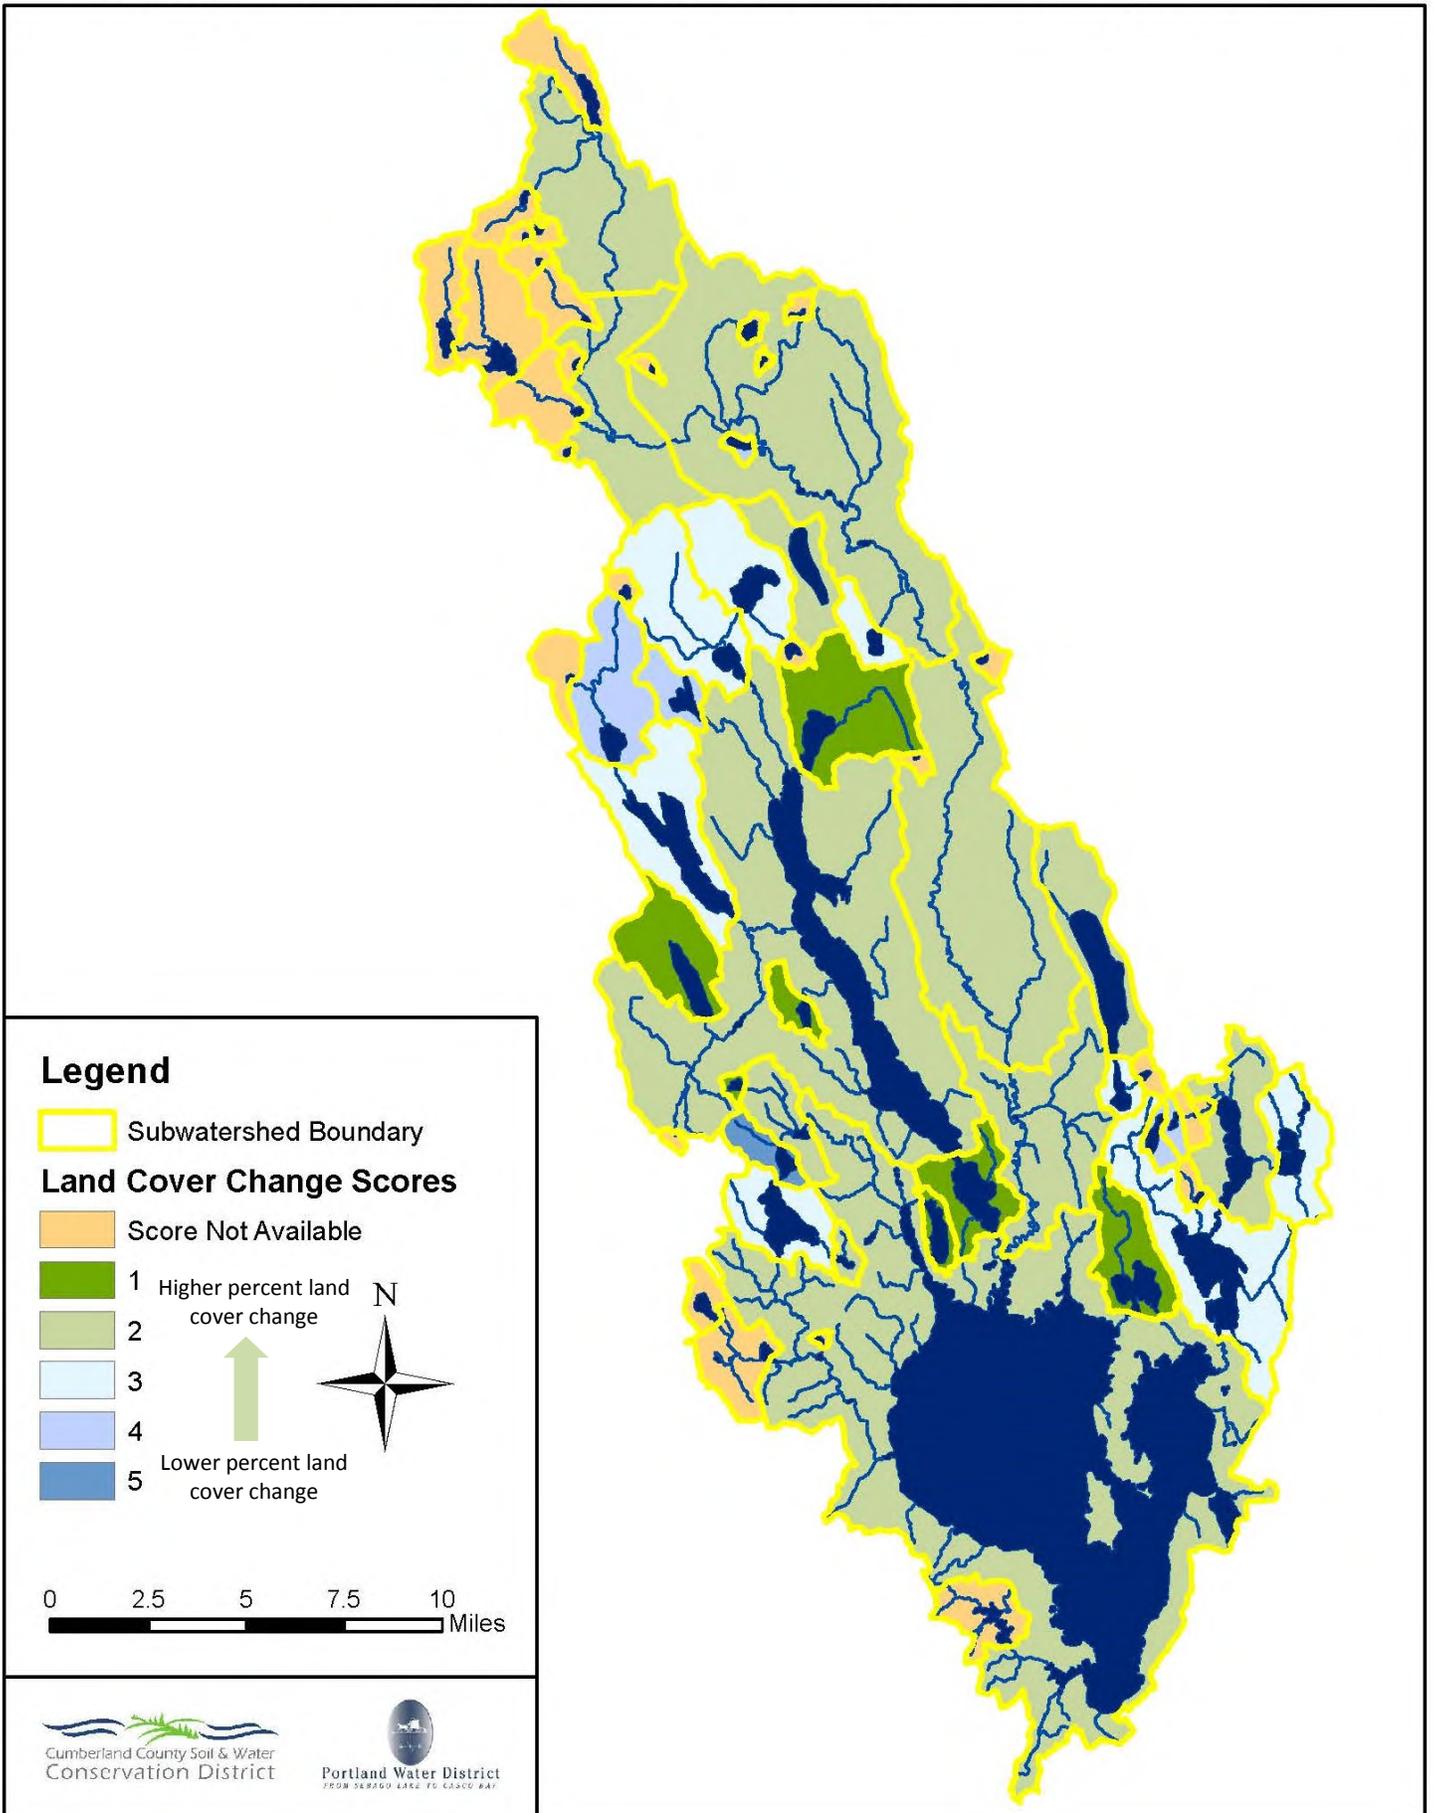
Figure 9. Sebago Lake subwatershed land cover change scores.

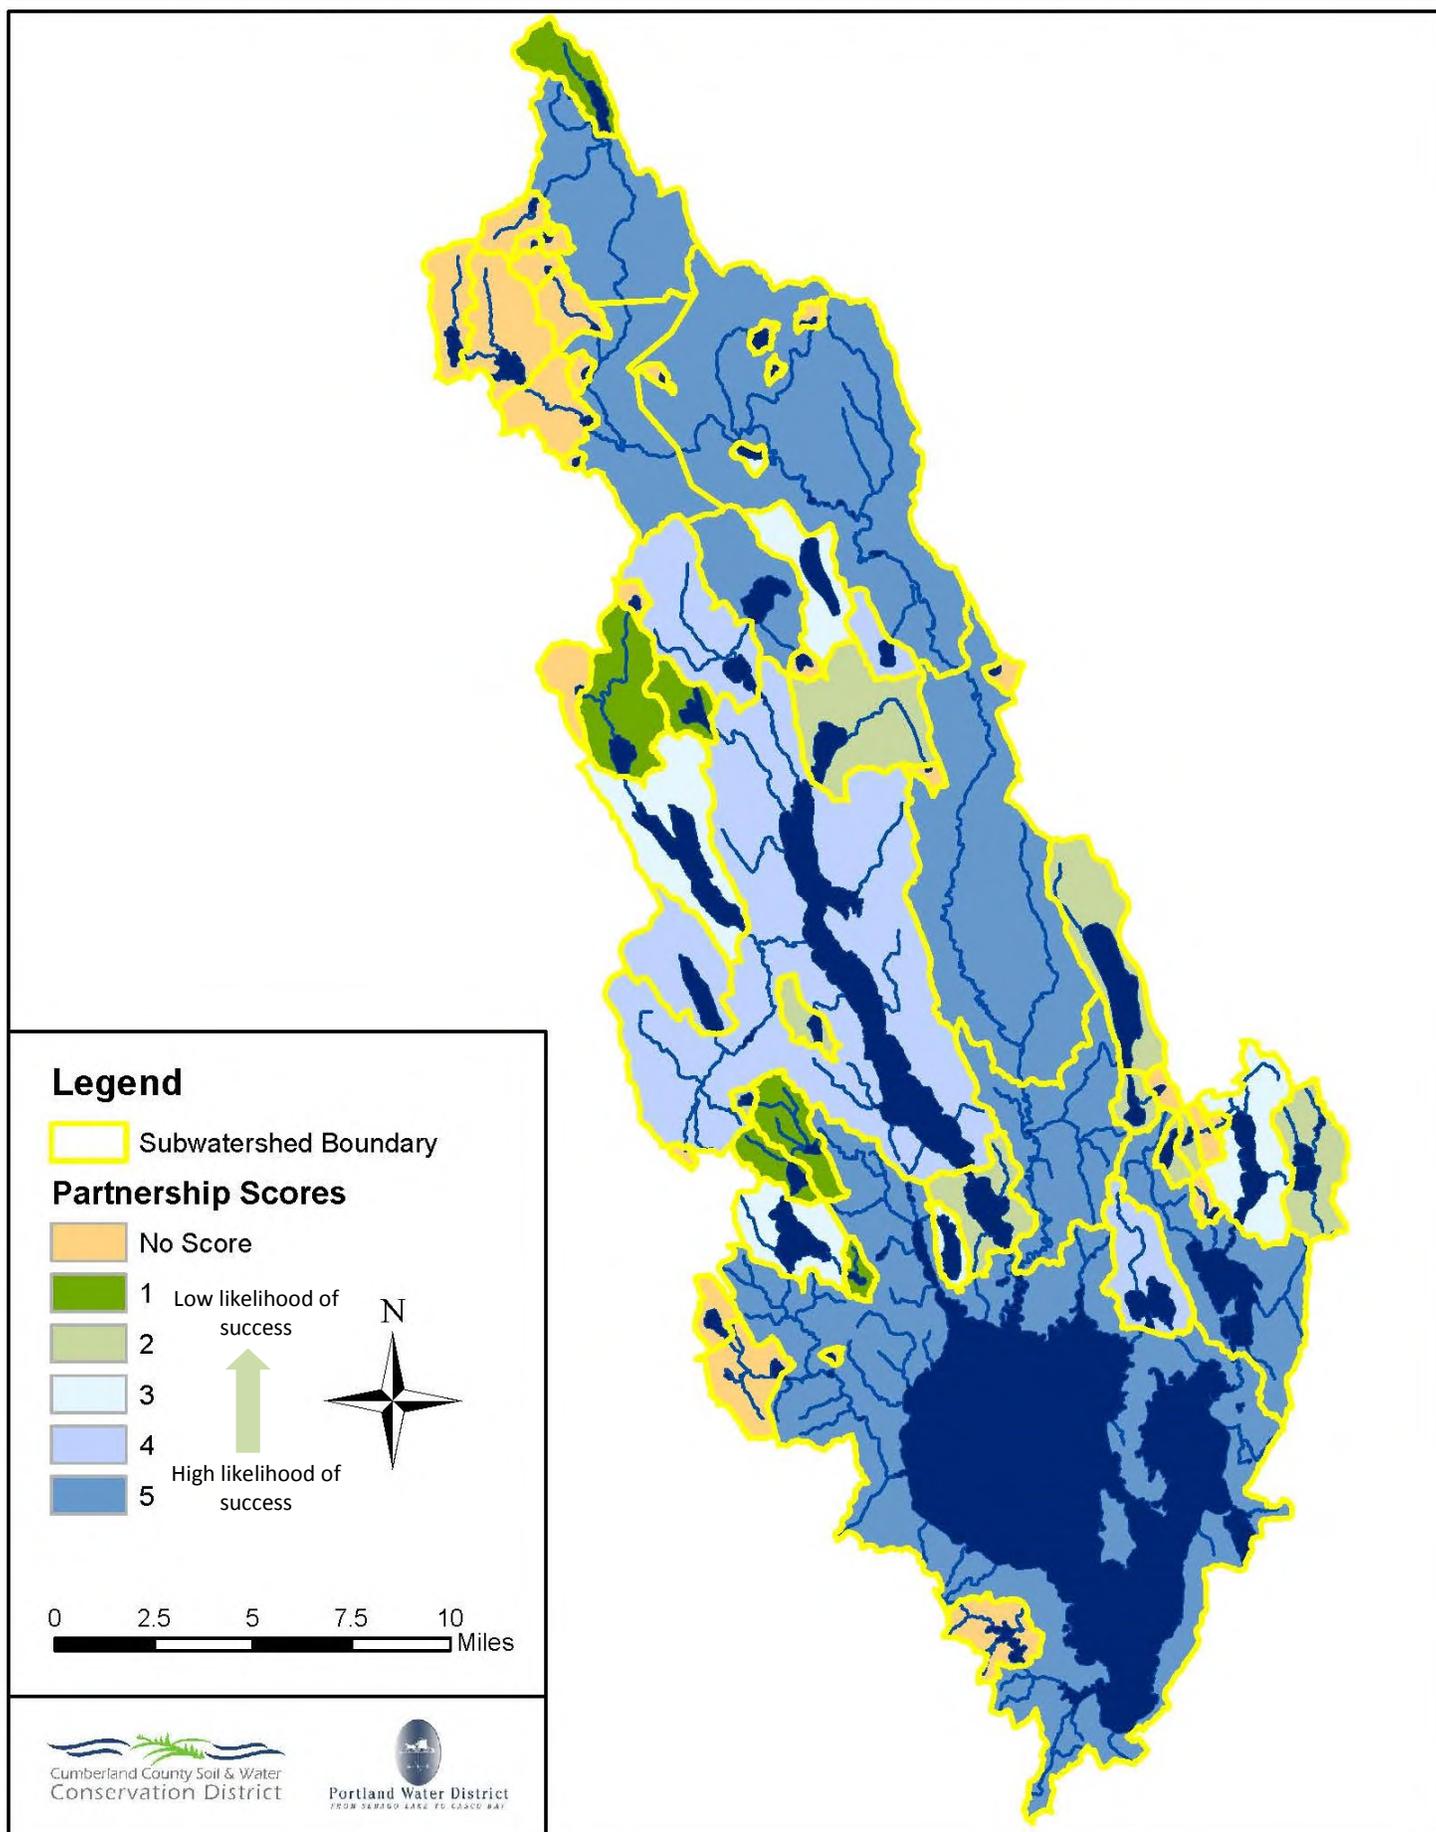
Figure 10. Sebago Lake subwatershed partnership scores.
