SEBAGO LAKE

SUBWATERSHED ASSESSMENT AND PRIORITIZATION

September 2015

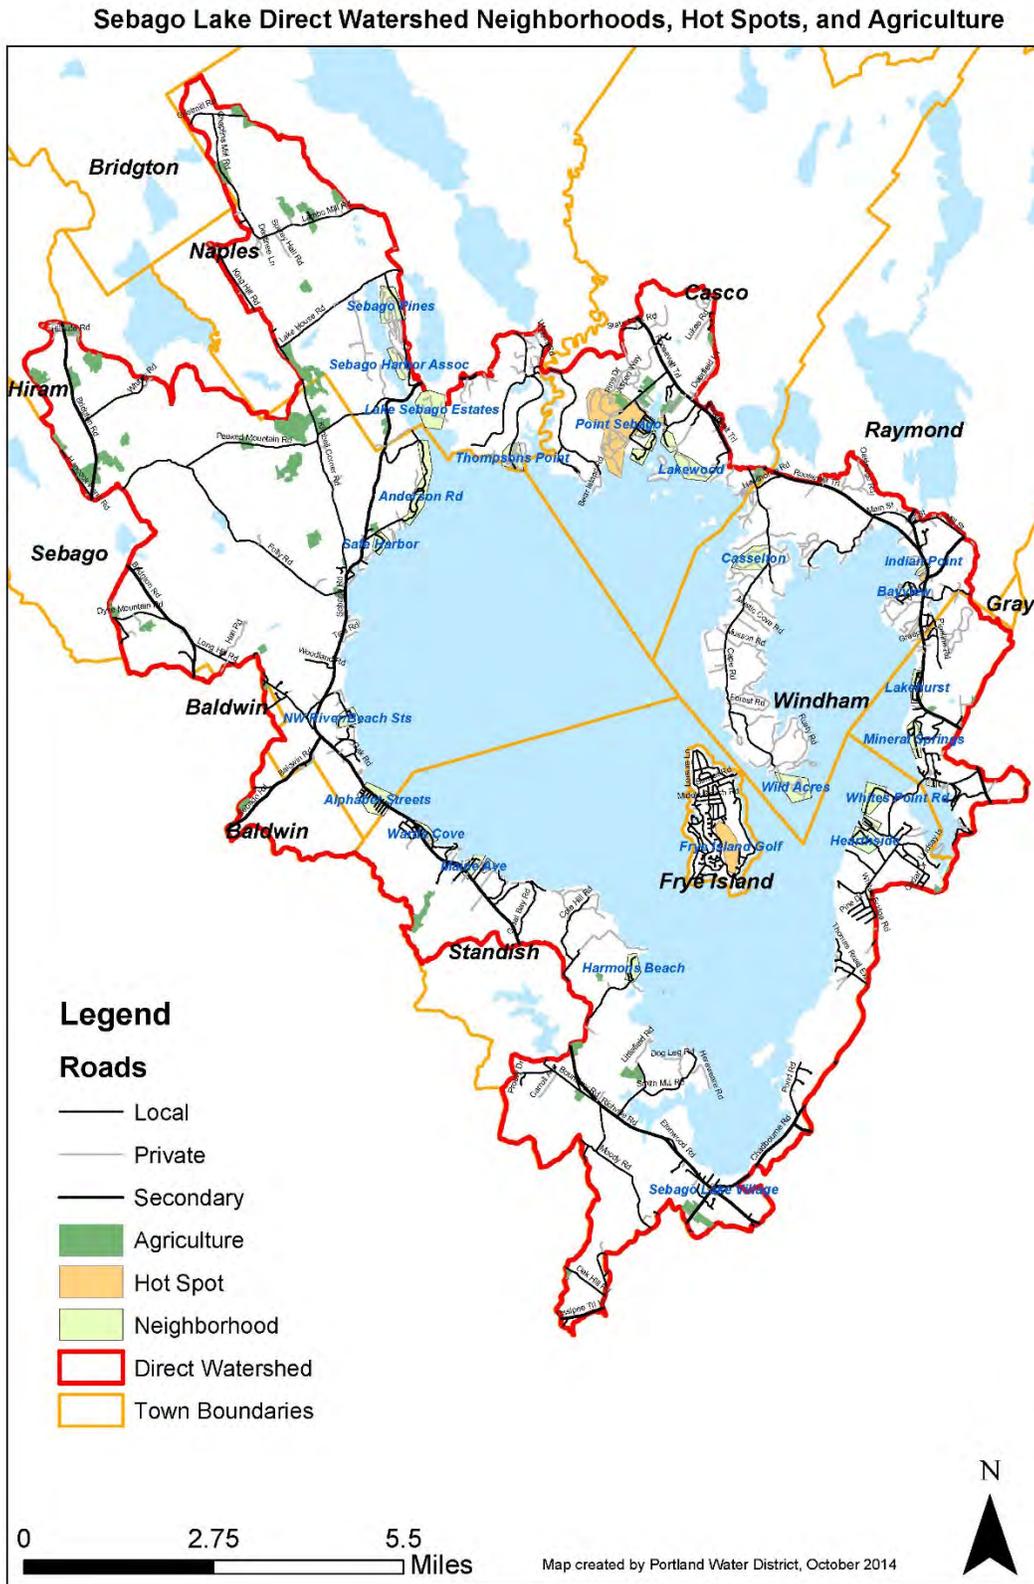
Figure 2: Sebago Lake Neighborhood and Hotspot Location Map

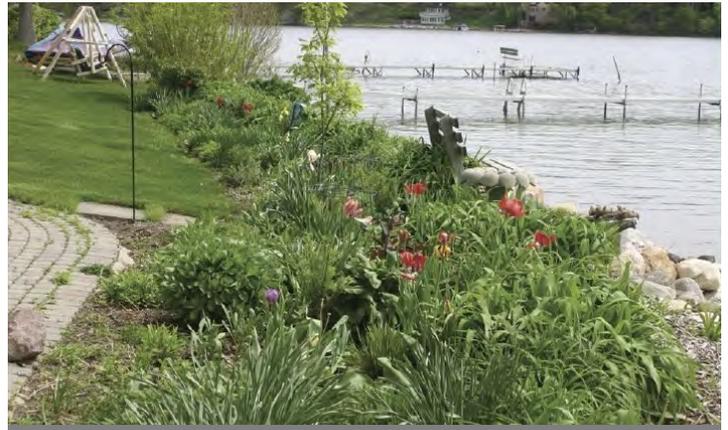
A vegetated buffer at the water's edge is beautiful and also helps to keep the lake clean. A swath of plants catches sediment and other pollutants before they enter the lake.

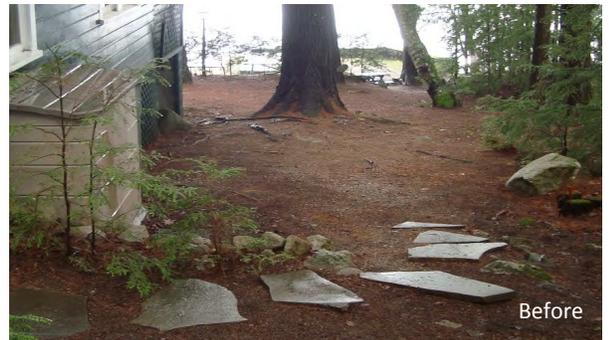
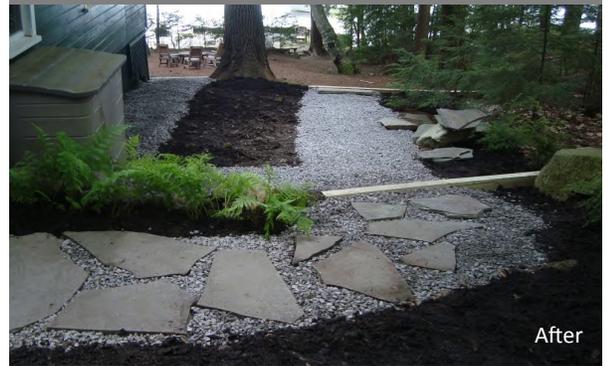
Before

Landowners can implement many simple practices to help keep their lake clean. Providing a clear path to the lakefront can also prevent soil loss.

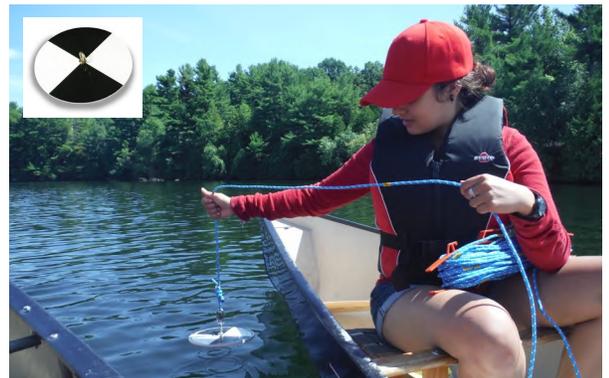
Volunteers and scientists have used Secchi disks (inset) to measure water clarity in lakes and seas since the late 1800s.

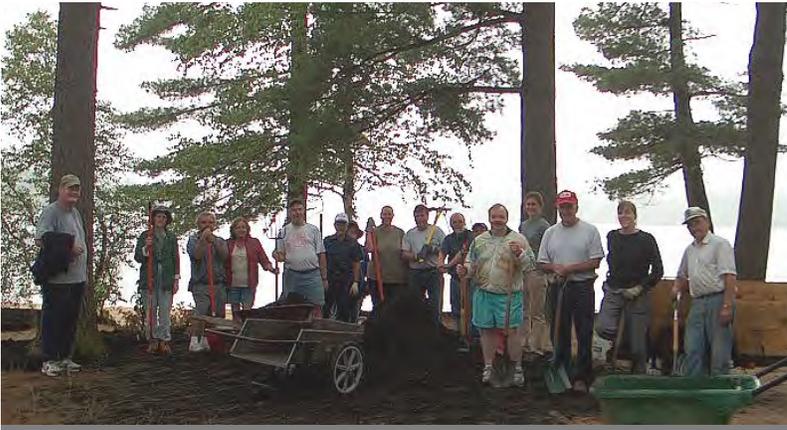
The shoreline planting at Bear Pond drew many community members. Other soil erosion measures observed during the Watershed Survey include water diverters, waterbars across driveways, and dripline trenches under roof edges.

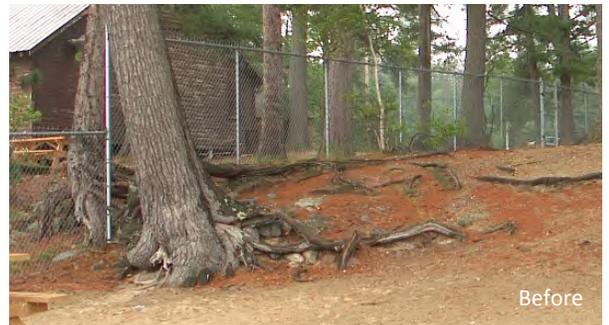
Before

Landowners can implement many simple practices to help keep their lake clean. Providing coverage for roots helps keep trees healthy and can prevent erosion as well.

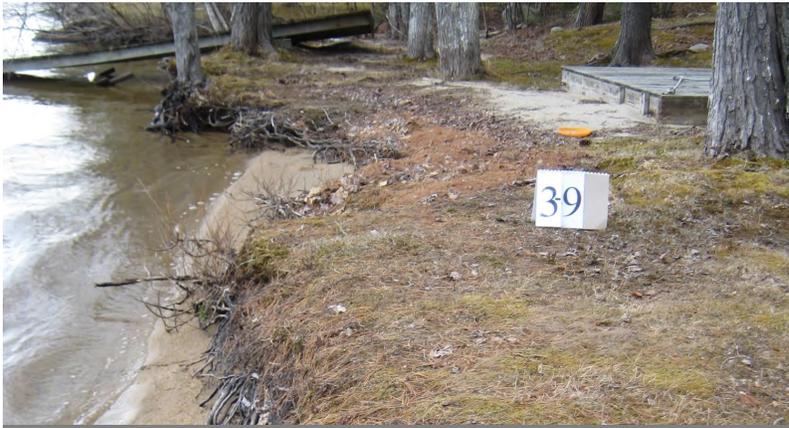
A watershed survey throughout the land that drains to Brandy Pond identified areas that should be improved. Above, shoreline erosion has cut into tree roots. The combination of many such sites can add up, damaging pond health.

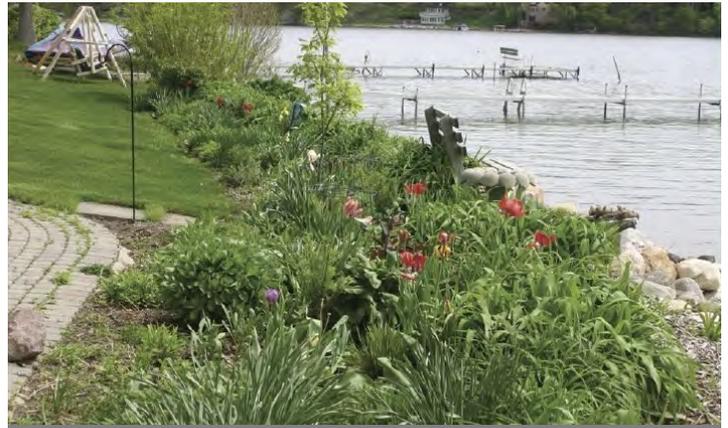
A vegetated buffer at the water's edge is beautiful and also helps to keep the lake clean. A swath of plants catches sediment and other pollutants before they enter the lake.

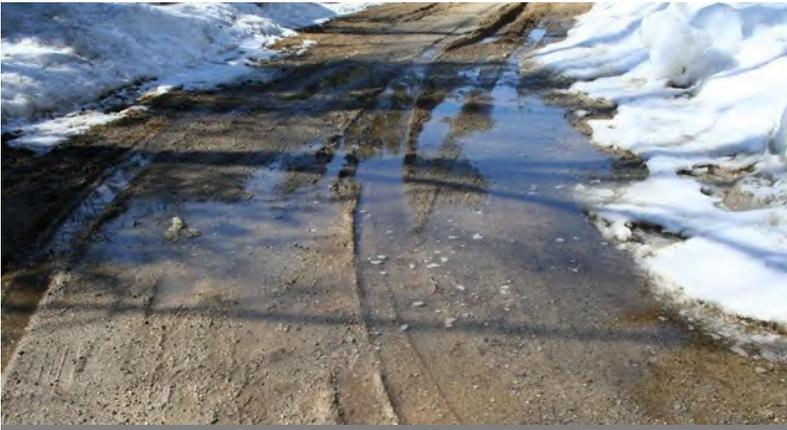
To preserve the health of Cold Rain Pond, modifications will be needed to area roads. Erosion of unpaved roads washes soil and nutrients into ponds, which can lead to algal blooms and decreased oxygen levels.

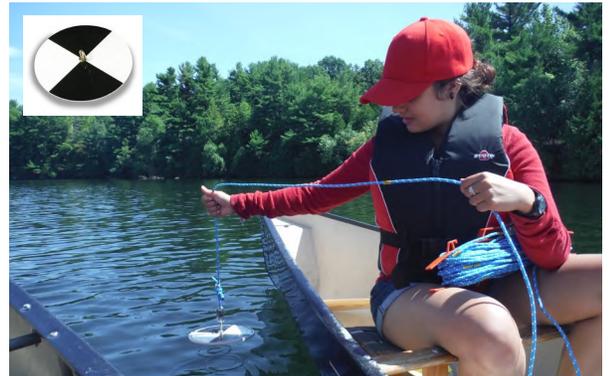
Volunteers and scientists have used Secchi disks (inset) to measure water clarity in lakes and seas since the late 1800s.

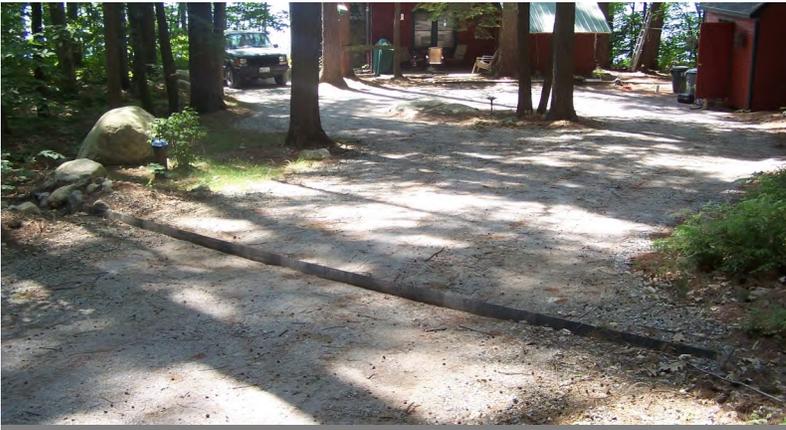
The Crystal Lake Watershed Survey found several improperly cared for unpaved roads. Above, a diversion bar directs surface runoff into vegetation to absorb the water, preventing it from flowing directly into the lake.

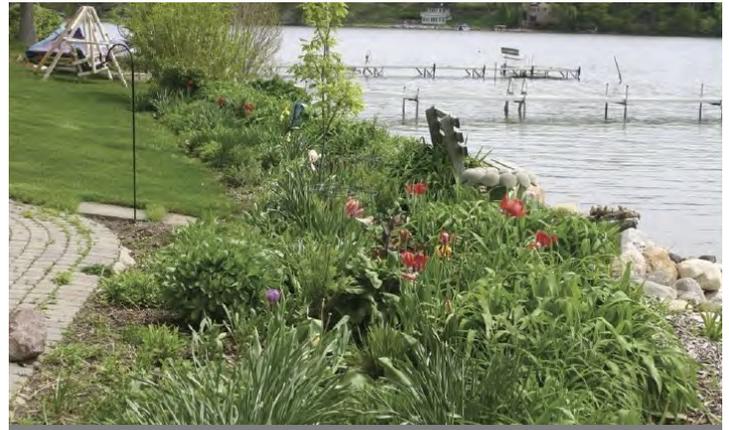
A vegetated buffer at the water's edge is beautiful and also helps to keep the lake clean. A swath of plants catches sediment and other pollutants before they enter the lake.

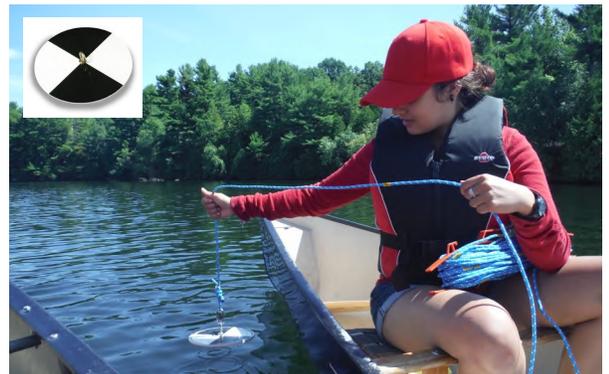
Volunteers and scientists have used Secchi disks (inset) to measure water clarity in lakes and seas since the late 1800s.

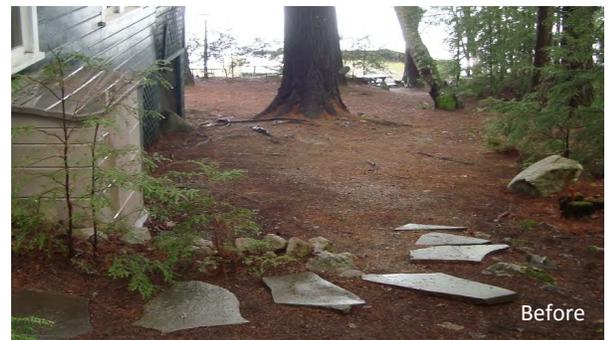
Before

Landowners can implement many simple practices to help keep their lake clean. Providing a clear path to the lakefront can also prevent soil loss.

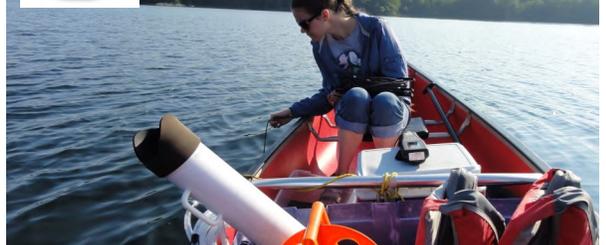
Volunteers and scientists have used Secchi disks (inset) to measure water clarity in lakes (shown here on Foster Pond) and seas since the late 1800s. *Photo credit: Colin Holme*

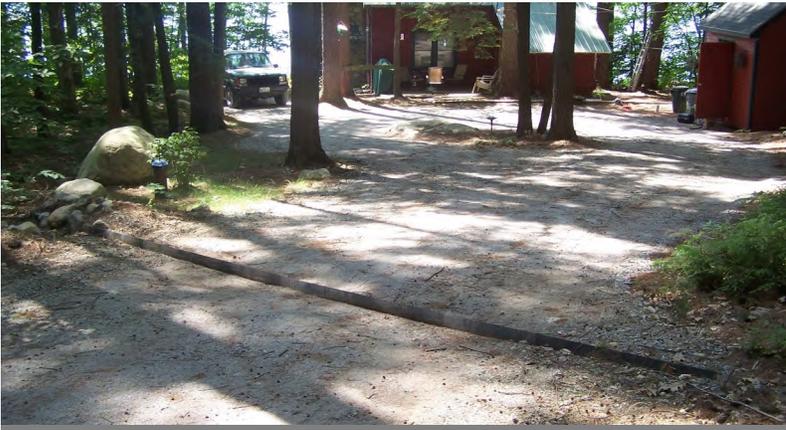
The Highland Lake Watershed Project, which ended in 2008, reduced soil erosion around the lake. Area volunteers and members of supporting organizations installed improvements like the water diverter shown above.

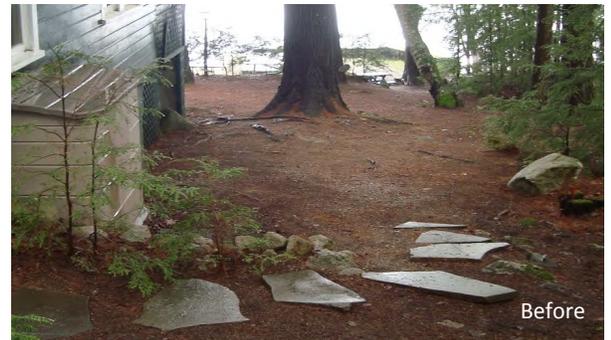
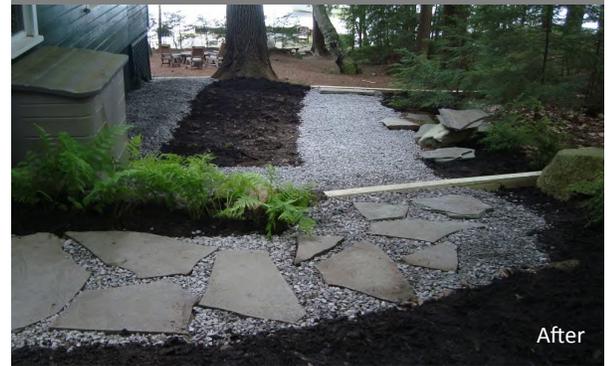
Before

Landowners can implement many simple practices to help keep their lake clean. Providing a clear path to the lakefront can also prevent soil loss.

After

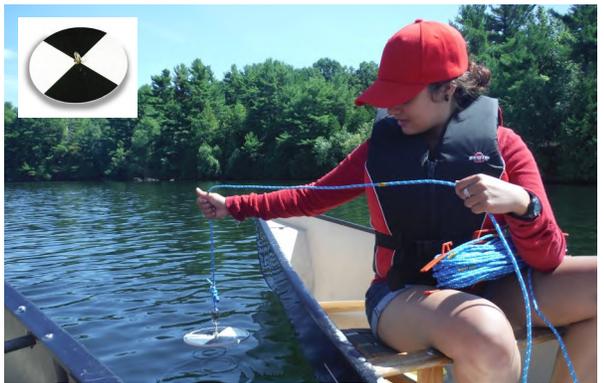
Volunteers and scientists have used Secchi disks (inset) to measure water clarity in lakes and seas since the late 1800s.

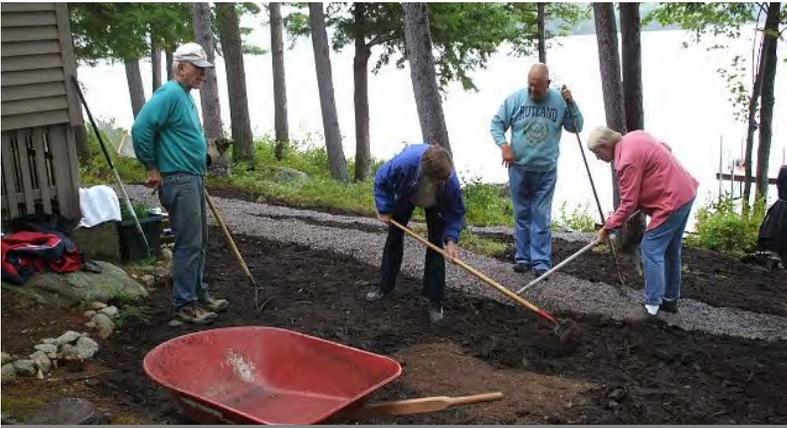
In 2007, the Island Pond Survey found that erosion along the lakefront was concerning. Reducing soil erosion can be completed by area volunteers. Planting shrubs and perennials (as shown above) helps hold soil in place.

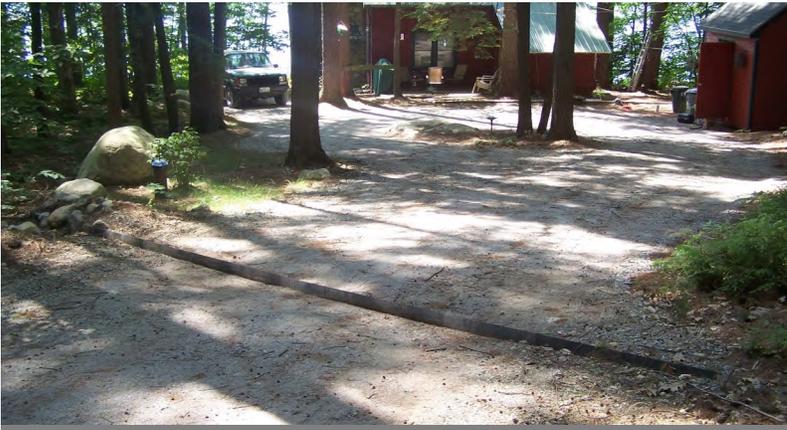
The Keoka Lake Improvement Project utilized area volunteers and members of supporting organizations to install measures to reduce soil erosion. Water diverters, shown above, reduce erosion of unpaved roads.

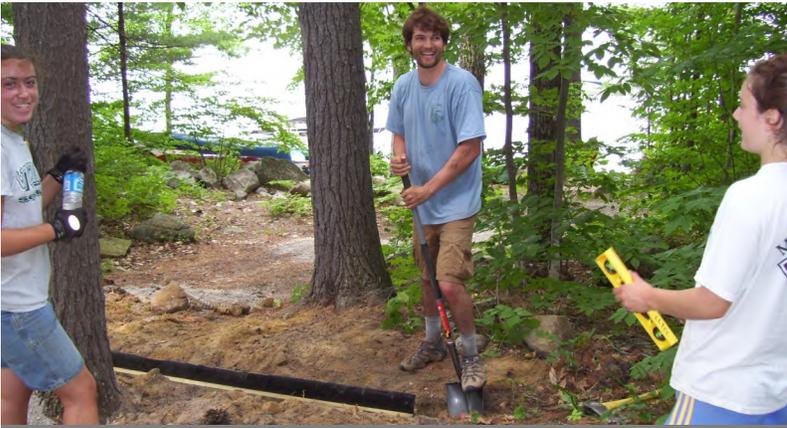
Soil erosion is a common concern around the region's lakes and ponds. Above, Long Lake Youth Conservation Corps (2007) members install a water diverter to direct water to the side of the pathway instead of carrying soil into the Lake.

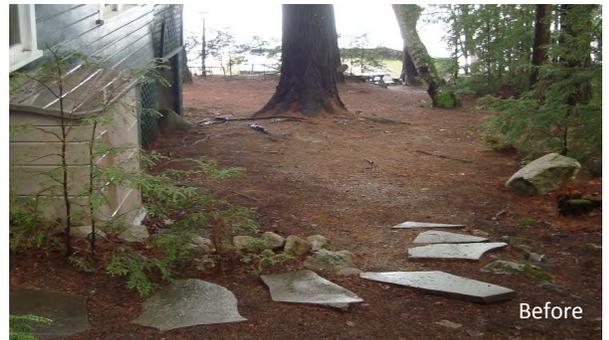
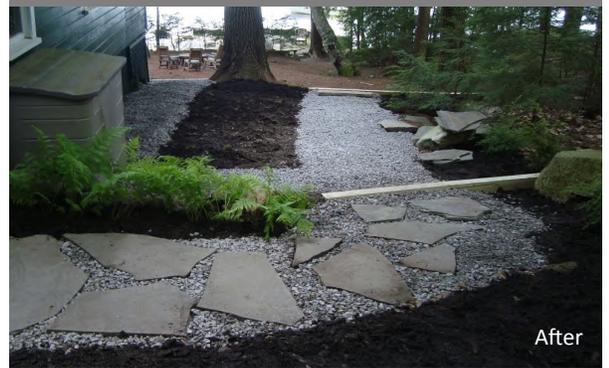
Before

Landowners can implement many simple practices to help keep their lake clean. Providing a clear path to the lakefront can also prevent soil loss.

After

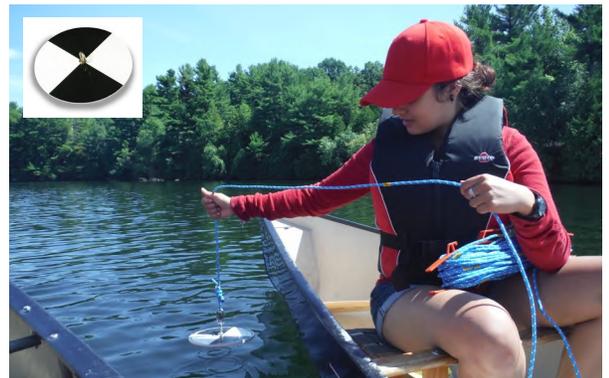
Volunteers and scientists have used Secchi disks (inset) to measure water clarity in lakes and seas since the late 1800s.

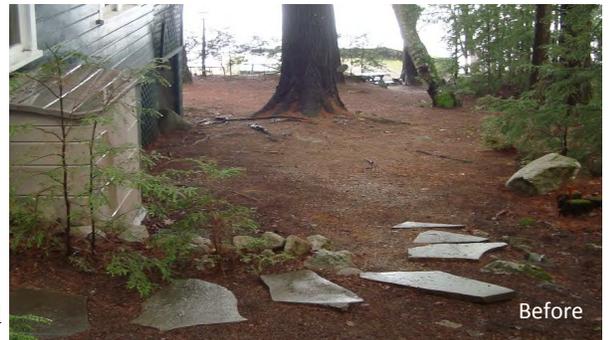
Before

Landowners can implement many simple practices to help keep their lake clean. Providing a clear path to the lakefront can also prevent soil loss.

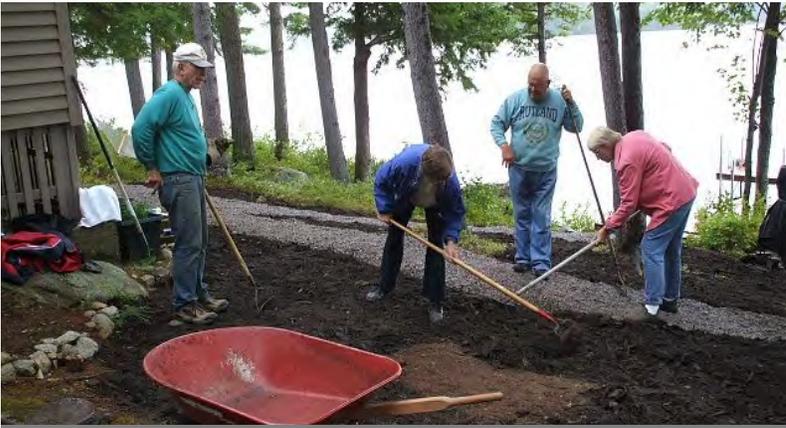
To counteract the pollution entering the pond from development, landowners can employ many simple practices on their property. Shown above is a group spreading mulch and planting perennials to hold soil in place.

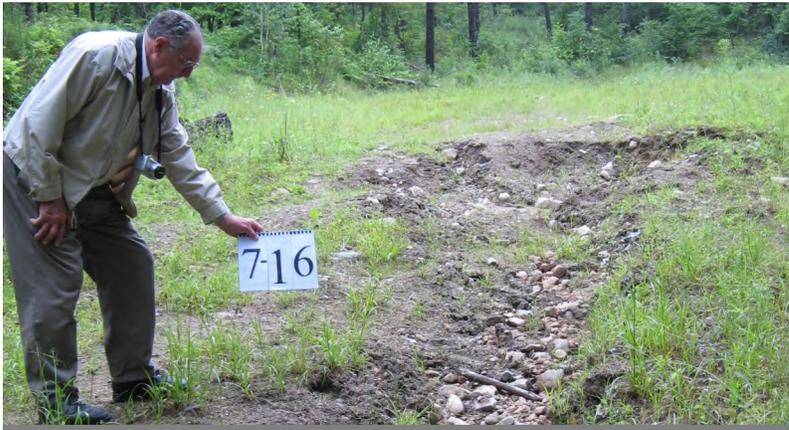
The Pleasant Lake/Parker Pond Conservation Project aimed to significantly reduce erosion and the export of sediment and phosphorus into the waters. Above, a site needing stabilization and improvement is documented.

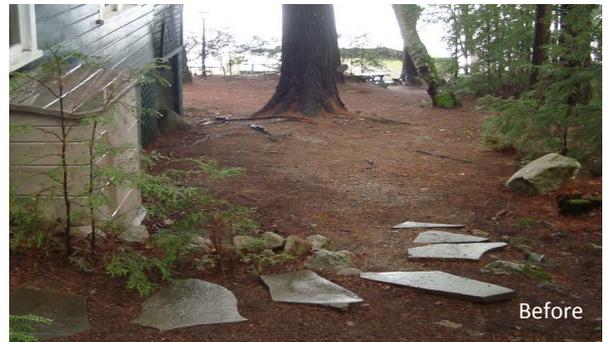
Before

Landowners can implement many simple practices to help keep their lake clean. Providing a clear path to the lakefront can also prevent soil loss.

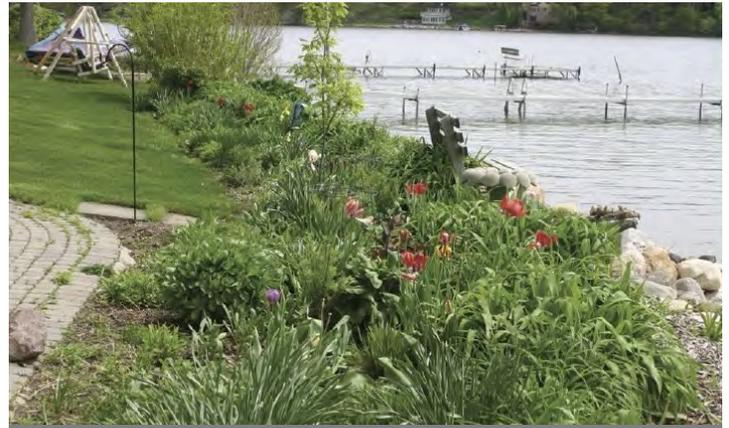
A vegetated buffer at the water's edge is beautiful and also helps to keep the lake clean. A swath of plants catches sediment and other pollutants before they enter the lake.

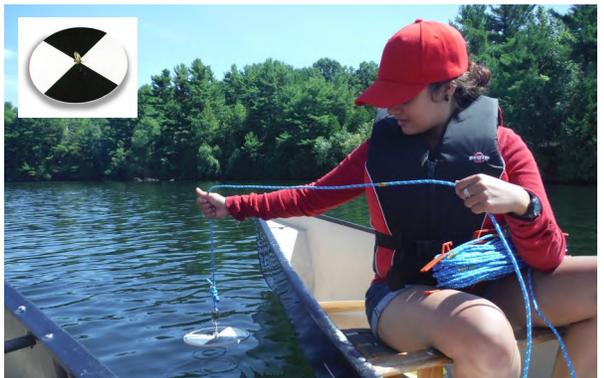
Volunteers and scientists have used Secchi disks (inset) to measure water clarity in lakes and seas since the late 1800s.

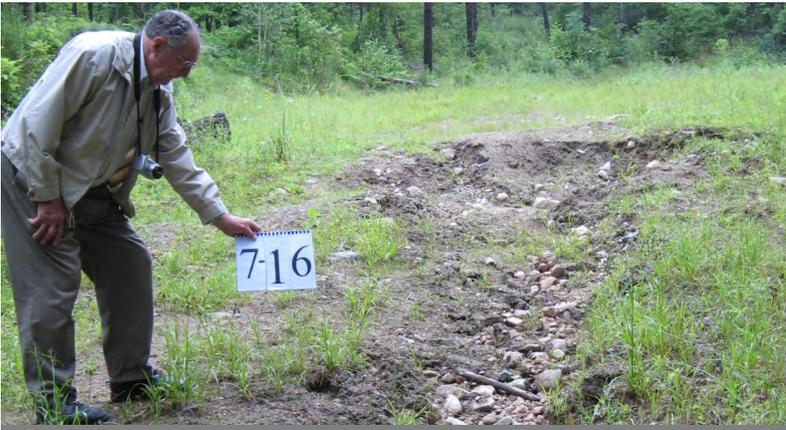
The Pleasant Lake/Parker Pond Conservation Project aimed to significantly reduce erosion and the export of sediment and phosphorus into the waters. Above, a site needing stabilization and improvement is documented.

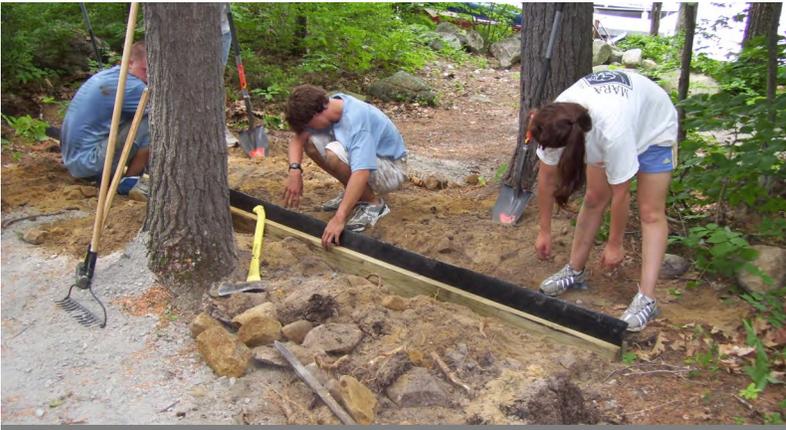
Installation of water diverters, like shown above, significantly reduces soil erosion and transport of sediment into the water. By diverting water towards the vegetated sides, the soil stays in place.

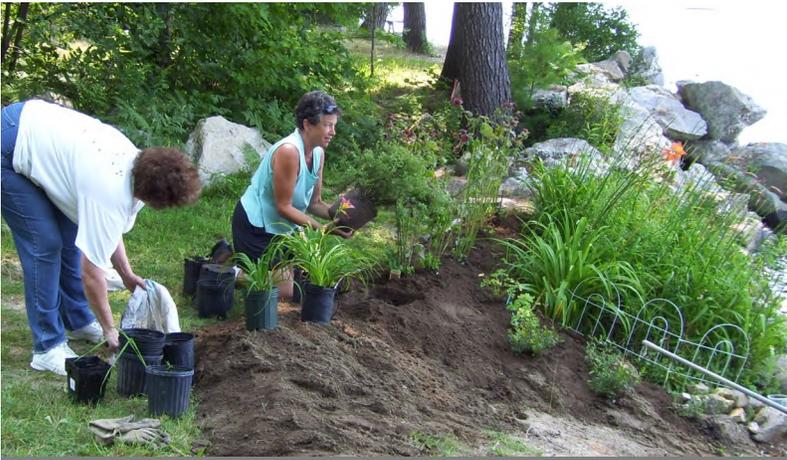
Volunteers on a Thomas Pond property plant a buffer zone to stabilize landscaping, the slope, and soil.

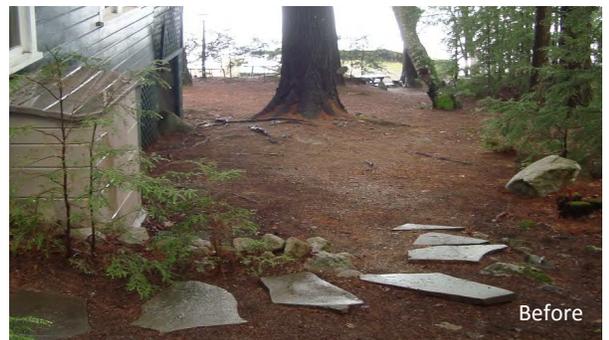
Landowners can implement many simple practices to help keep their lake clean. Providing a clear path to the lakefront can also prevent soil loss.

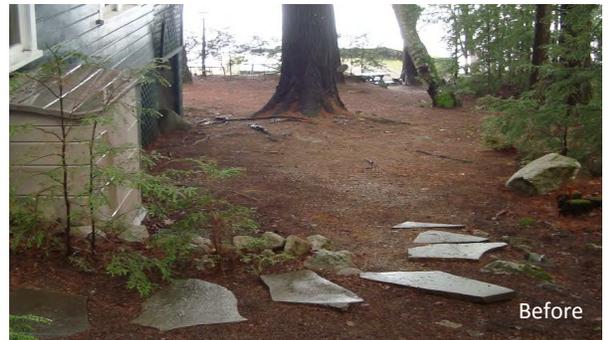
Landowners can implement many simple practices to help keep their lake clean. Providing a clear path to the lakefront can also prevent soil loss.
